## **APPENDIX 7-8**

# **Water Monitoring Location Descriptions**

Last updated November 2006

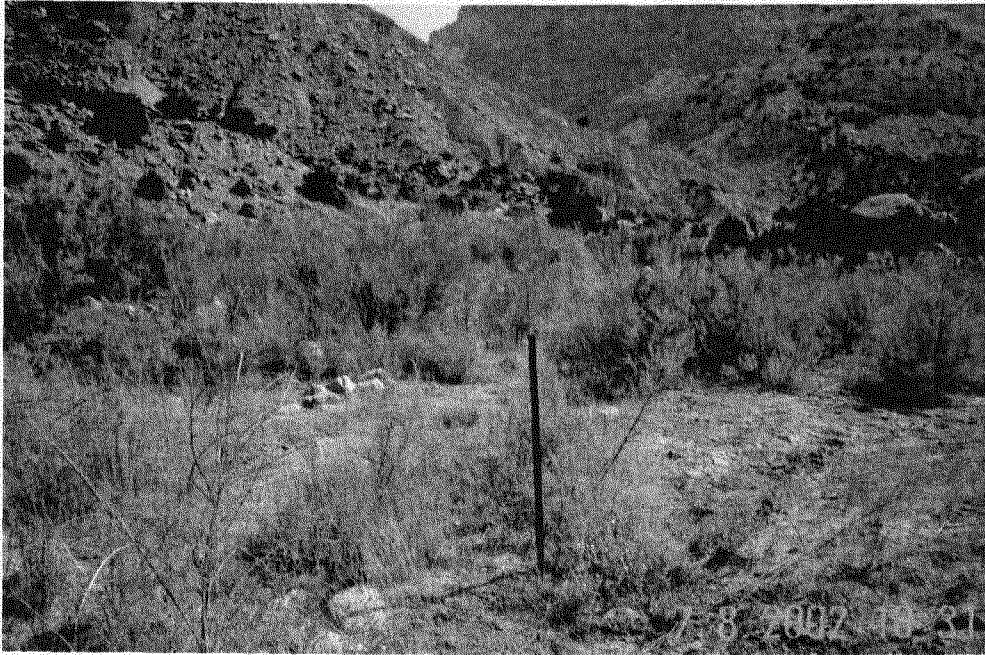
**L-1-S**

**Location:** In Lila Canyon wash North of the permit area. Stream reach is intermittent by definition but ephemeral acting (See Appendix 7-7 & Plate 7-4). The wash above and below flows only as a result of spring run-off or storm events. Located in the Mancos Shale at an elevation of 5,830 feet.

**General:** The Sunnyside coal seam does not exist at this location. Since L-1-S is located off the permit area and subsidence is not a possibility, there is no potential for Lila Canyon Mine to negatively affect this monitoring location. The permittee has never observed amphibians at or near this location.

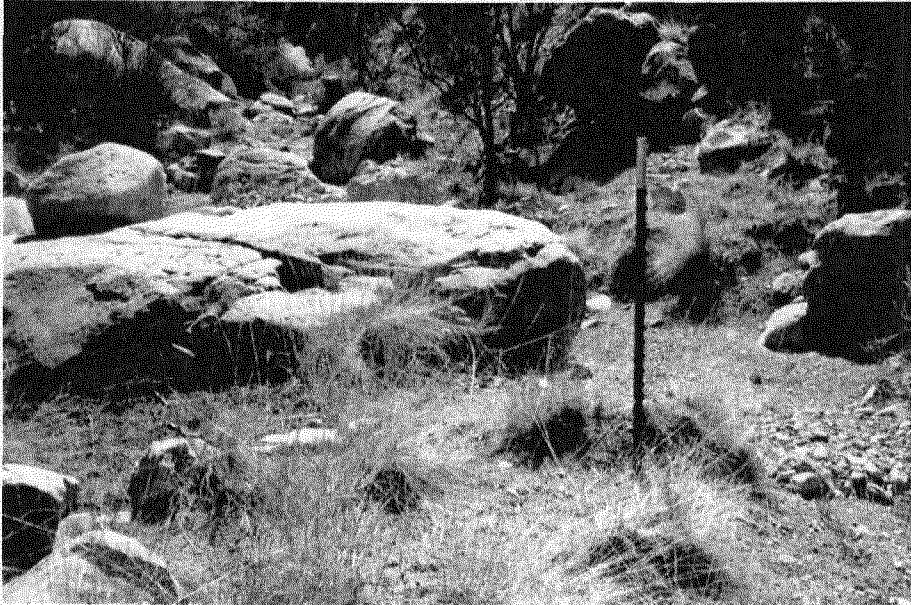
**L-2-S**

- Location:** L-2-S is located In the Right Fork of Lila Canyon wash South of and upstream of the permit area. Stream reach is ephemeral by definition (See Appendix 7-7& Plate 7-4). The wash above and below flows only as a result of spring run-off or storm events. Located in the Mancos Shale at an elevation of 5,950 feet.
- General:** The Sunnyside coal seam does not exist at this location. Since L-2-S is located off the permit area and subsidence is not a possibility, there is no potential for Lila Canyon Mine to negatively affect this monitoring location. The permittee has never observed amphibians at or near this location.
- Vegetation description:** Habitat overstory adjacent to the dry streambed monitoring location is Pinyon-Juniper, isolated sagebrush, and needle and thread grass.

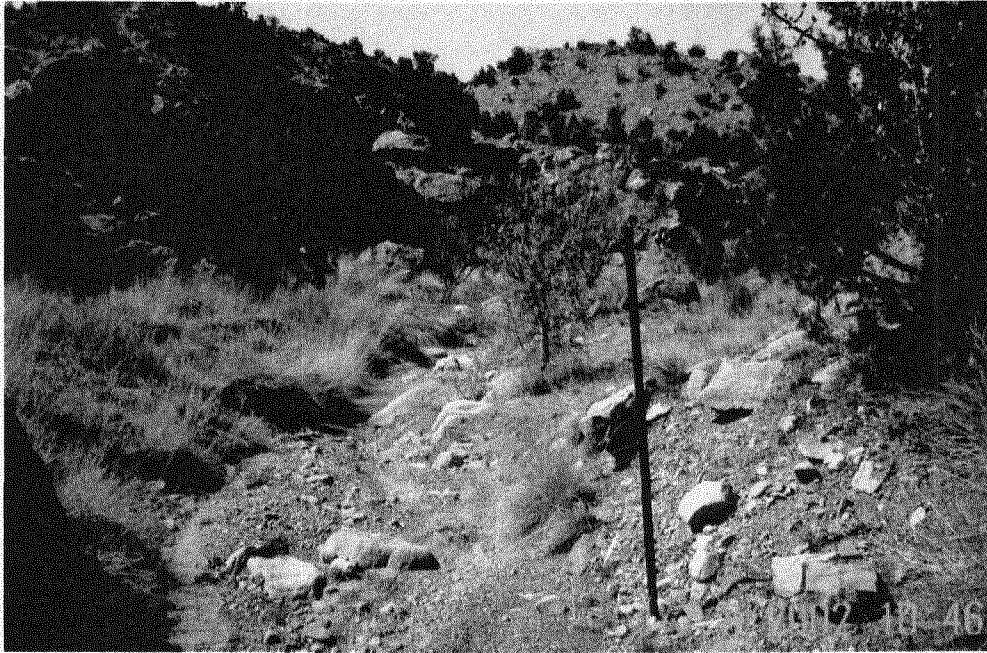
**L-3-S**

**Location:** Located in the Right Fork of Lila Canyon wash South of and down stream of the permit area. Stream reach is ephemeral by definition (See Appendix 7-7& Plate 7-4). The wash above and below flows only as a result of spring run-off or storm events. The Sunnyside coal seam does not exist in this location. Located in the Mancos Shale at an elevation of 5,750 feet.

**General:** Since L-3-S is located off the permit area and subsidence is not a possibility, there is no potential for the Lila Canyon Mine to negatively affect this monitoring location. The permittee has never observed amphibians at or near this location.

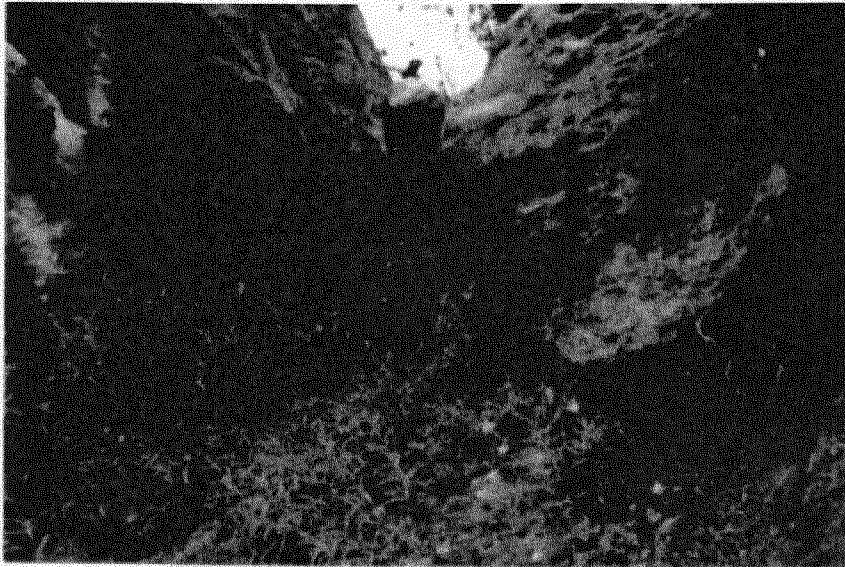
**L-6-G**  
**(H-18) Lila Canyon**

**Location:** Located in Lila Canyon within the Permit area. The old Horse Canyon Mine has already undermined this monitoring location with no impact. Stream reach is intermittent by definition but is ephemeral acting (See Appendix 7-7 & Plate 7-4). The wash above and below the spring flows only as a result of spring run-off or storm events. Located in the Upper Price River near the contact of the Flagstaff/ North Horn and the Upper Price River Formations at an elevation of 7280 feet.

**General:** The coal seam has been previously mined under this location. The spring lies approximately 1,800 feet above the mined out Sunnyside coal seam. There is no potential for Lila Canyon Mine to negatively impact this monitoring location. The permittee has never observed amphibians at or near this location.

Since the operator has never observed flow at this location, and a new location upstream has been determined to be more suitable for monitoring, this site will be terminated. L-11-G has been established to replace L-6-G as a monitoring location.

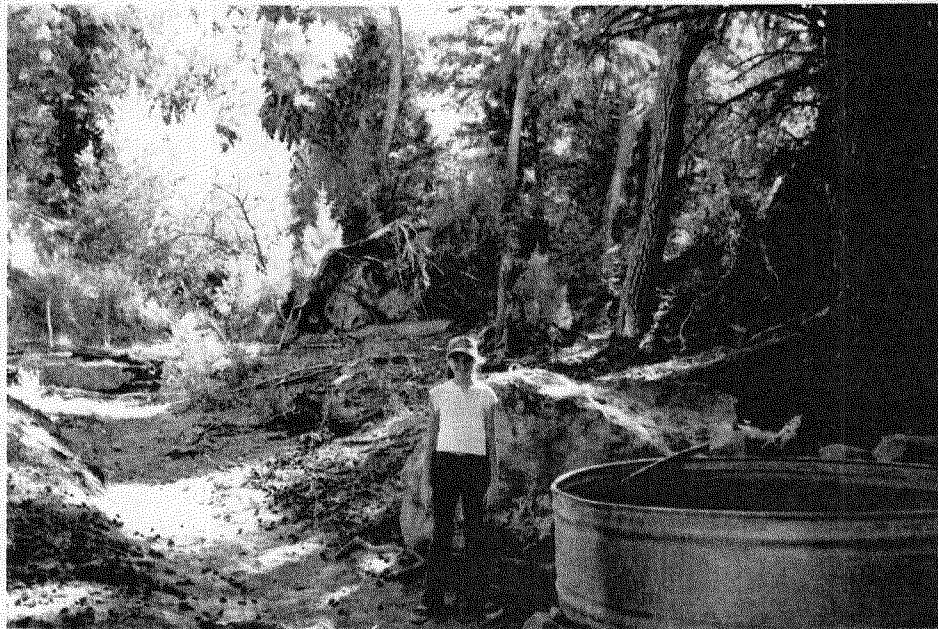
**L-7-G**  
**Cottonwood Spring**

**Location:** Located in Cottonwood Canyon approximately .5 miles from the intersection of Cottonwood Canyon with Little Park Wash. This spring is located approximately .25 miles inside the permit area. Located in the Flagstaff/ North Horn Formation at an elevation of 7360 feet. Stream reach is intermittent by definition but is ephemeral acting (See Appendix 7-7 & Plate 7-4). Flow from the spring flows approximately 200 feet down stream where it evaporates or is absorbed. The drainage above and below Cottonwood spring flows only as a result of spring run-off or storm events.

**General:** The coal seam at this location lies approximately 2,500 feet below the spring. Due to the depth of the coal and the tendency for the overlying formations to swell and seal, there is little potential for Lila Canyon Mine to negatively impact this spring or recharge sources. The permittee has never observed amphibians at or near this location.

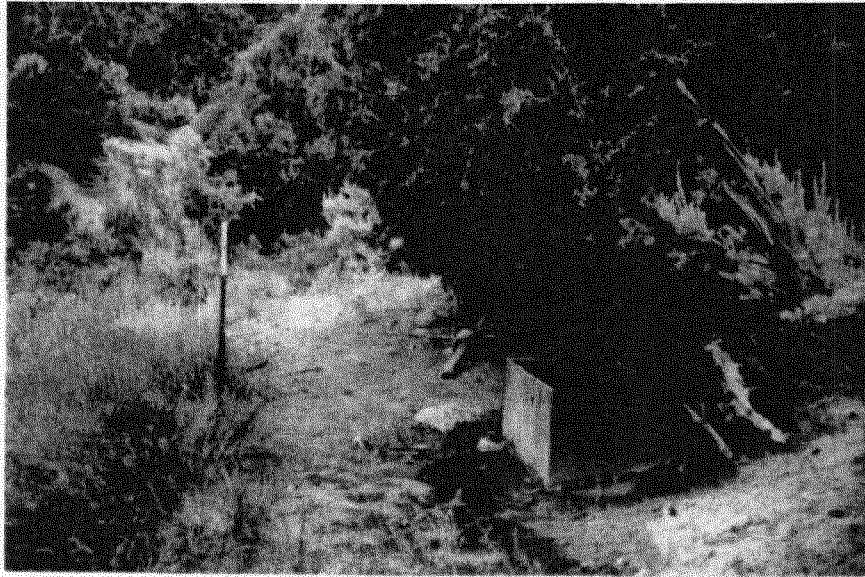
**L-8-G**  
**Above IPA #1**

**Location:** L-8-G is located in an unnamed canyon that the operator refers to as IPA #1, approximately 1 mile above Piezometer IPA #1. Located in the Flagstaff/ North Horn Formation at an elevation of 7360 feet. Stream reach is intermittent by definition but is ephemeral acting (See Appendix 7-7 & Plate 7-4). Flow from the spring flows approximately 200 feet down stream where it evaporates or is absorbed. The drainage above and below this spring flows only as a result of spring run-off or storm events.

**General:** The coal seam at this location lies approximately 2,400 feet below the spring. The spring is located .5 miles to the East and off of, the permit area. Due to its location, .5 miles outside of the limit of subsidence, depth of the coal, and the tendency for the overlying formations to swell and seal, there is no potential for Lila Canyon Mine to negatively impact this spring or recharge sources. The permittee has never observed amphibians at or near this location.

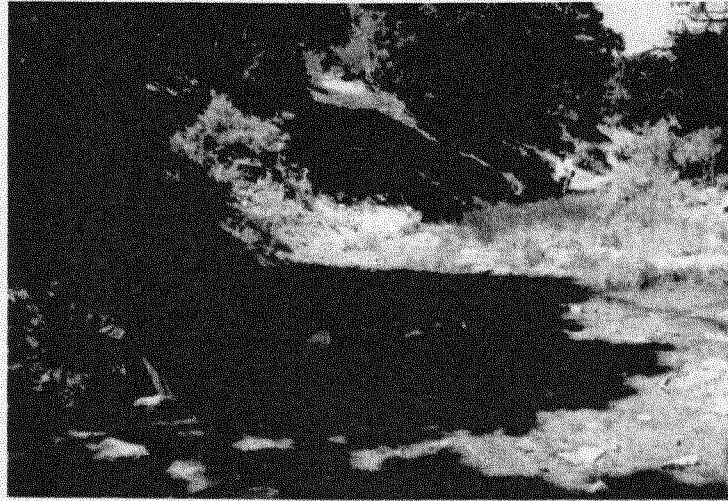
**L-9-G**  
**Pine Spring**

**Location:** L-9-G is located in an unnamed side canyon approximately 1.25 miles from Little Park Wash. Located in the Flagstaff/ North Horn Formation at an elevation of 7200 feet. Stream reach is intermittent by definition but is ephemeral acting (See Appendix 7-7 & Plate 7-4). Flow from the spring flows approximately 400 feet down stream where it evaporates or is absorbed. The drainage above and below this spring flows only as a result of spring run-off or storm events.

**General:** The coal seam at this location lies approximately 2,300 feet below the spring. The spring is located along the channel and just inside of the permit area. Due to its location, thickness of the overburden, and the tendency for the overlying formations to swell and seal, there is no potential for Lila Canyon Mine to negatively impact this spring or recharge sources. The permittee has never observed amphibians at or near this location.

**Vegetation description:** A wet meadow habitat is present within the area of the monitoring site. An overstory of Pinyon-Juniper and sagebrush grass lies immediately adjacent along each side of this site. The wet meadow habitat was washed out or covered with sand and gravel as a result of storm events in Aug 2003. Indications of localized riparian habitat exists. Moss, sedge, willow, columbine observed.

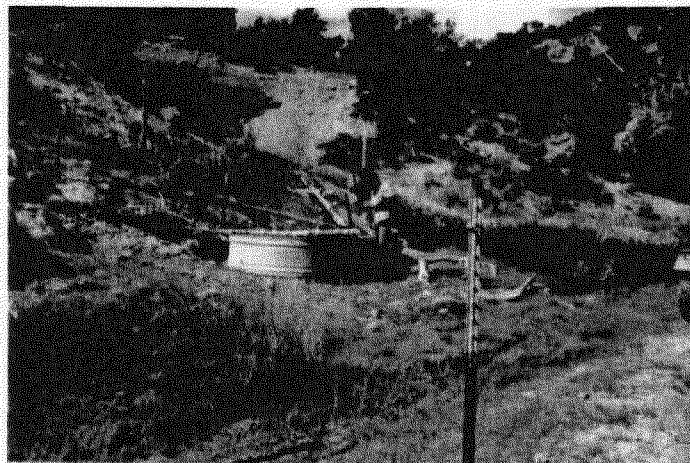
**L-10-G**  
**Williams Draw Spring**

**Location:** L-10-G is located in Williams Draw approximately 1.25 miles South and East of the permit area. Located in the Upper Price River near the contact of the Flagstaff/ North Horn and the Upper Price River Formations at an elevation of 6720 feet. Stream reach is intermittent by definition but is ephemeral acting (See Appendix 7-7 & Plate 7-4). Flow from the spring flows approximately 200 feet down stream where it evaporates or is absorbed. The drainage above and below this spring flows only as a result of spring run-off or storm events.

**General:** The coal seam at this location lies approximately 1250 feet below the spring. The spring is located over a mile outside of the limit of subsidence. Due to its location, outside the limit of subsidence, depth of the coal, and the tendency for the overlying formations to swell and seal, there is no potential for Lila Canyon Mine to negatively impact this spring or recharge sources. The permittee has never observed amphibians at or near this location.

Since this spring location is so far off the permit area a better site was identified where the information gathered would be more valuable. This site will be replaced by L-12-G.

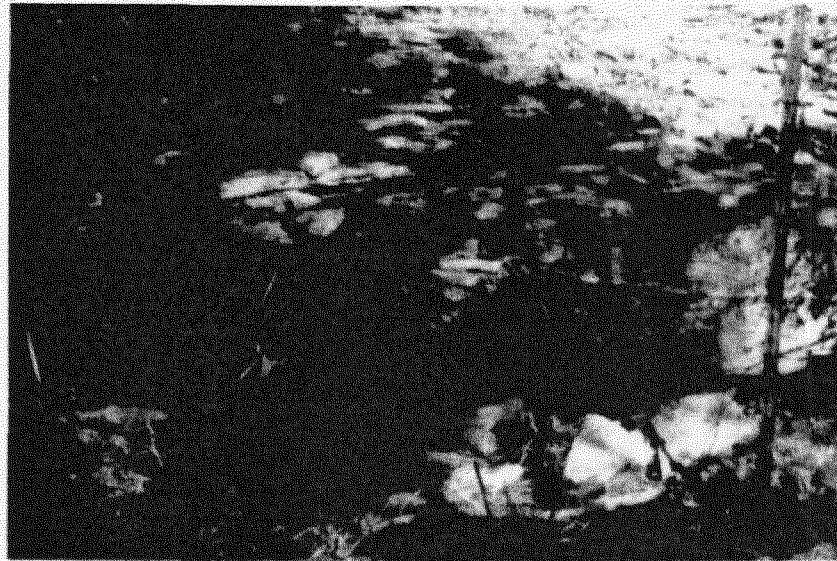
**L-11-G**  
**Mont/Leslie Springs Area**  
**Will Replace L-6-G**

**Location:** L-11-G is located in Lila Canyon within the Permit area. Located in the Upper Price River near the contact of the Flagstaff/ North Horn and the Upper Price River Formations at an elevation of 7360 feet. The old Horse Canyon Mine has already undermined this monitoring location with no impact. The spring flows for approximately 50 feet where it either evaporates or is absorbed. Stream reach is intermittent by definition but is ephemeral acting (See Appendix 7-7 & Plate 7-4). The wash flows only as a result of spring run-off or storm events.

**General:** The coal seam has been previously mined at this location. The spring lies approximately 1,900 feet above the mined out Sunnyside coal seam: There is no potential for Lila Canyon Mine to negatively impact this monitoring location. The permittee has never observed amphibians at or near this location.

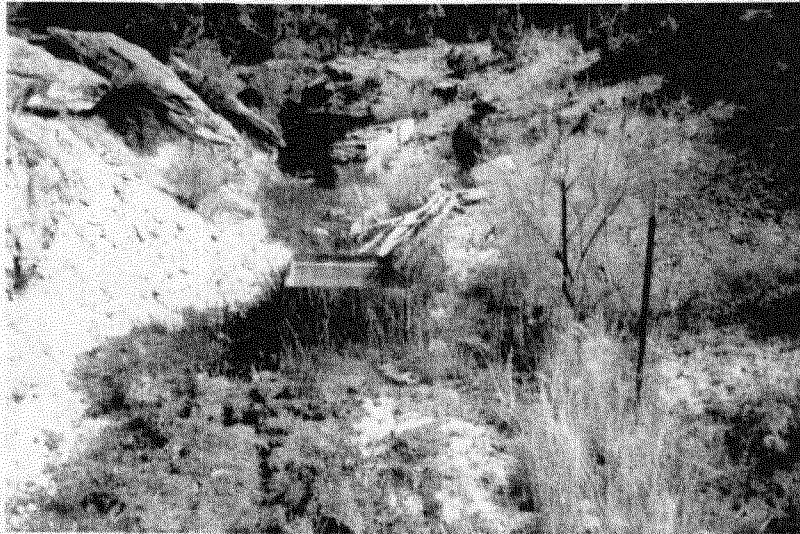
**L-12-G**  
**Will Replace L-10-G**

**Location:** L-12-G is located in an unnamed drainage on the south end of the permit area. Located in the Upper Price River at an elevation of 6800 feet. Stream reach is intermittent by definition but is ephemeral acting (See Appendix 7-7 & Plate 7-4). Flow from the spring flows approximately 100 feet down stream where it evaporates or is absorbed. The drainage above and below this spring flows only as a result of spring run-off or storm events.

**General:** The coal seam at this location lies approximately 1100 feet below the spring. The spring is located just outside of the limit of subsidence. Due to its location, outside the limit of subsidence, depth of the coal, and the tendency for the overlying formations to swell and seal, there is no potential for Lila Canyon Mine to negatively impact this spring or recharge sources. The permittee has never observed amphibians at or near this location.

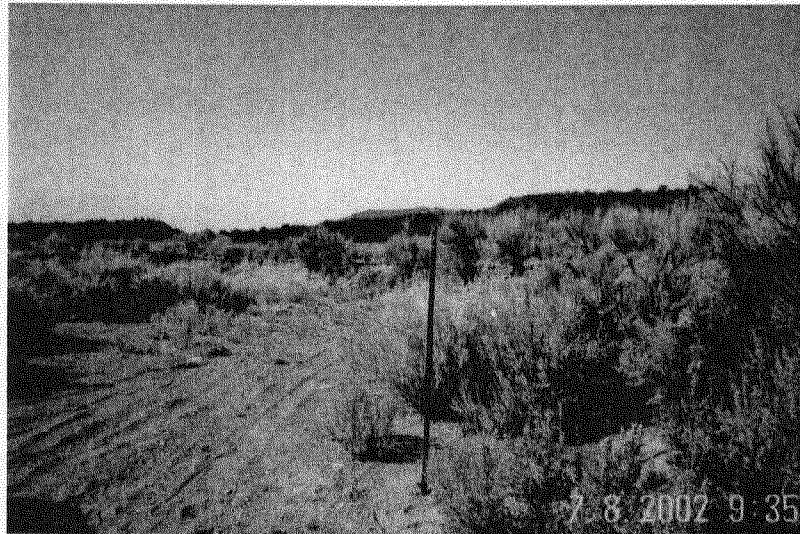
**L-13-S**  
**Little Park Wash**

**Location:** L-13-S is located in Little Park Wash at the road intersection. Located in Alluvium adjacent to the Upper Price River Formation at an elevation of 6840 feet. Stream reach is intermittent by definition but is ephemeral acting (See Appendix 7-7 & Plate 7-4). The drainage above and below this monitoring location flows only as a result of spring run-off or storm events.

**General:** The coal seam at this location lies approximately 1400 feet below the monitoring location. Due to its location, depth of the coal, and the tendency for the overlying formations to swell and seal, there is no potential for Lila Canyon Mine to negatively impact this monitoring location. The permittee has never observed amphibians at or near this location.

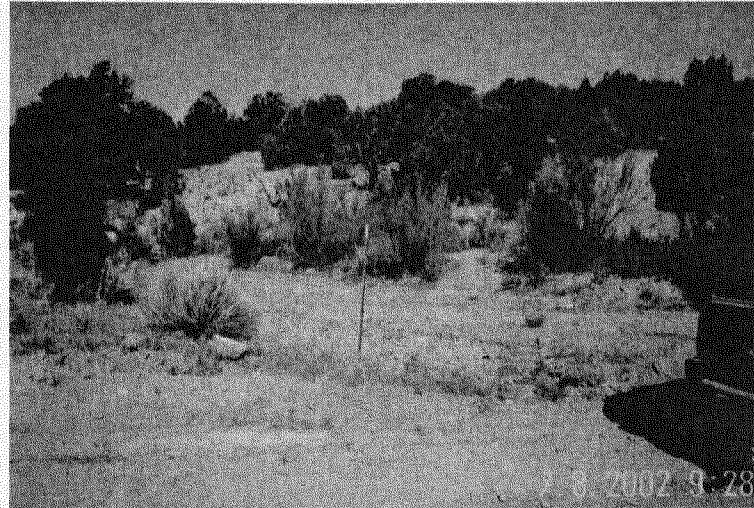
**L-14-S**  
**Wash Below L-12-G**

**Location:** L-14-S is located at the road intersection of the unnamed drainage below L-12-G. Located in the Upper Price River Formation at an elevation of 6690 feet. Stream reach is intermittent by definition but is ephemeral acting (See Appendix 7-7 & Plate 7-4). The drainage above and below this monitoring location flows only as a result of spring run-off or storm events.

**General:** The coal seam at this location lies approximately 1000 feet below the monitoring location. Due to the faulting this monitoring location is outside the mine projections and the projected limit of subsidence. As a result of its location, depth of the coal, and the tendency for the overlying formations to swell and seal, there is no potential for Lila Canyon Mine to negatively impact this monitoring location. The permittee has never observed amphibians at or near this location.

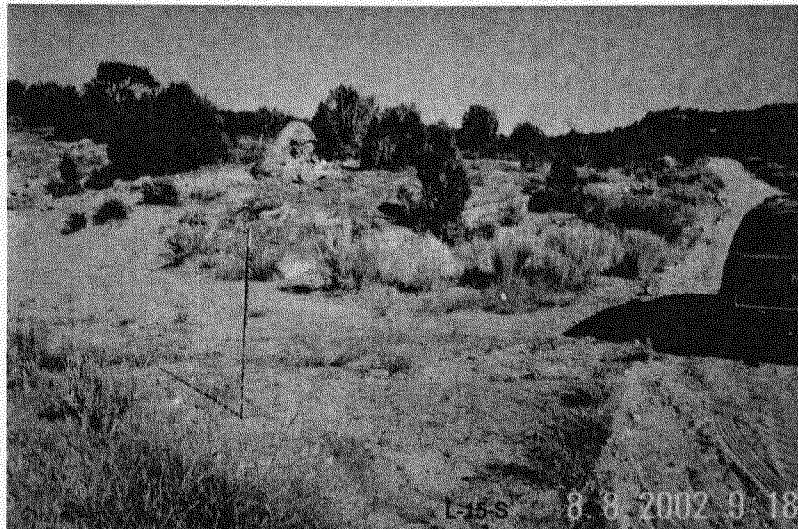
**L-15-S**  
**Williams Draw Wash**

**Location:** L-15-S is located at the road intersection of Williams Draw. Located in Alluvium adjacent to the Upper Price River Formation at an elevation of 6560 feet. The stream reach is intermittent by definition but is ephemeral acting (See Appendix 7-7 & Plate 7-4). The drainage above and below this monitoring location flows only as a result of spring run-off or storm events.

**General:** The coal seam at this location lies approximately 900 feet below the monitoring location. This site is located 1.25 miles South of the permit boundary. As a result of its location, there is no potential for Lila Canyon Mine to negatively impact this monitoring location. The permittee has never observed amphibians at or near this location.

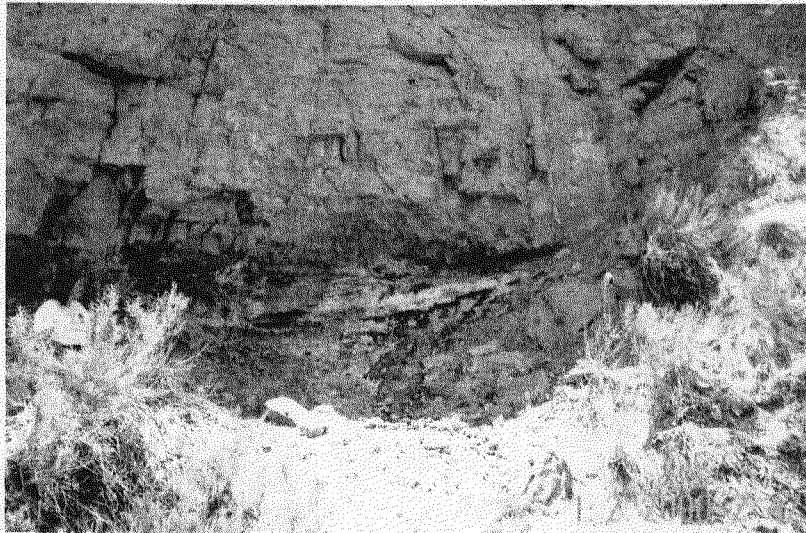
### **L-16-G Little Stink**

**Location:** Located in what has recently been named Stinky Spring Canyon by the Operator. The seep is located approximately 0.25 miles to the West of the permit area and within the Central Graben. The seep is located at the top of the Mancos Shale approximately 600 feet below the coal seam in a highly faulted area at an elevation of 5840 feet. The stream reach is intermittent by definition but is ephemeral acting (See Appendix 7-7 & Plate 7-4). The drainage above and below this monitoring location flows only as a result of spring run-off or storm events.

**General:** Due to its location, outside the permit area, outside the limit of subsidence, within the Central Graben, and being 600 feet below the coal seam, there is no potential for Lila Canyon Mine to negatively impact this spring or recharge sources. This location is used by Rocky Mountain Bighorn Sheep; however, no evidence of the sheep using the poor quality water has been documented. The permittee has never observed amphibians at or near this location.

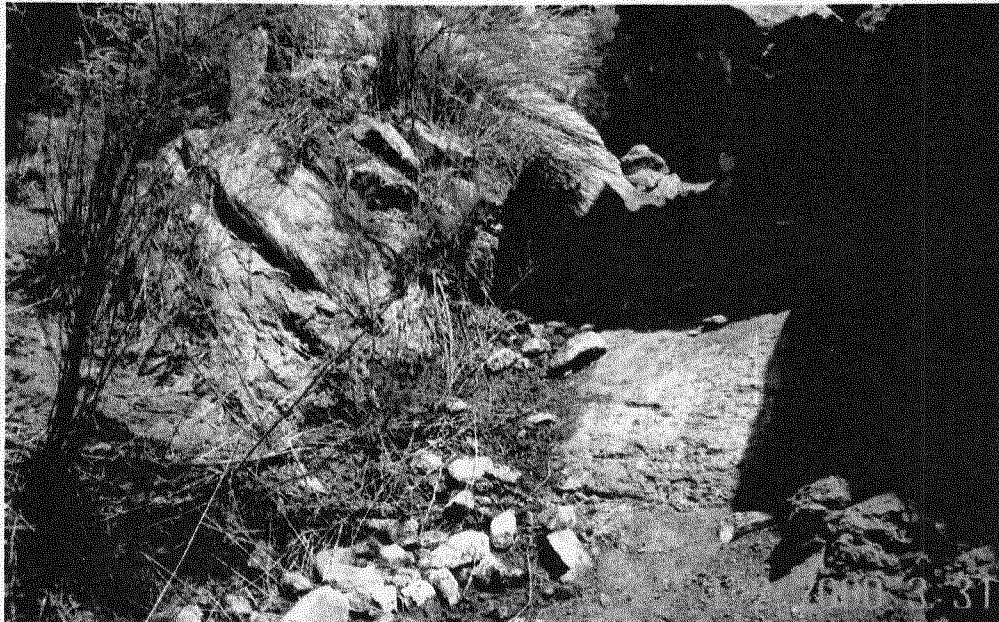
### **L-17-G Big Stink**

- Location:** Located in what has recently been named Stinky Spring Canyon. The seep is located approximately 0.25 miles to the West of the permit area, 0.1 mile above L-16-S, and within the Central Graben. The seep is located at the top of the Mancos Shale approximately 500 feet below the coal seam in a highly faulted area at an elevation of 5920 feet. The stream reach is intermittent by definition but is ephemeral acting (See Appendix 7-7 & Plate 7-4). The drainage above and below this monitoring location flows only as a result of spring run-off or storm events.

- General:** Due to its location, outside the permit area, outside the limit of subsidence, and being 500 feet below the coal seam, there is no potential for Lila Canyon Mine to negatively impact this stream reach. This location is used by Rocky Mountain Bighorn Sheep; however, no evidence of the sheep drinking the poor quality water has been documented. The permittee has never observed amphibians at or near this location.

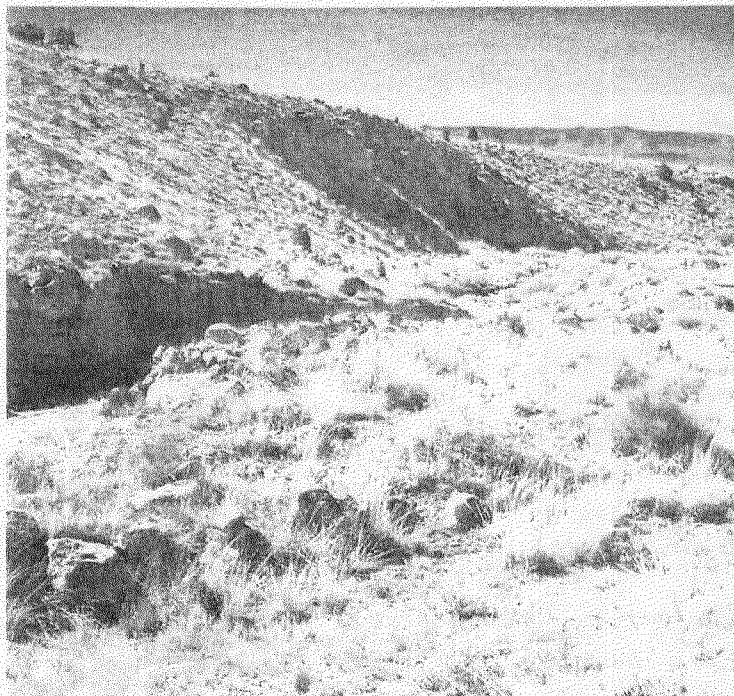
### L-18-S Stinky Spring Wash

- Location:** Loca ted in what has recently been named Stinky Spring Canyon. The stream reach is intermittent by definition but is ephemeral acting (See Appendix 7-7 & Plate 7-4). The drainage above and below this monitoring location flows only as a result of spring run-off or storm events.
- General:** Due to its location, outside the permit area, outside the limit of subsidence, and being 500 feet below the coal seam, there is no potential for Lila Canyon Mine to negatively impact this spring or recharge sources. This location is used by Rocky Mountain Bighorn Sheep; however, no evidence of the sheep drinking the poor quality water has been documented. The permittee has never observed amphibians at or near this location.
- Vegetation description:** The area surrounding the dry wash monitoring site consists primarily of mature sagebrush and Pinyon-Juniper habitat.

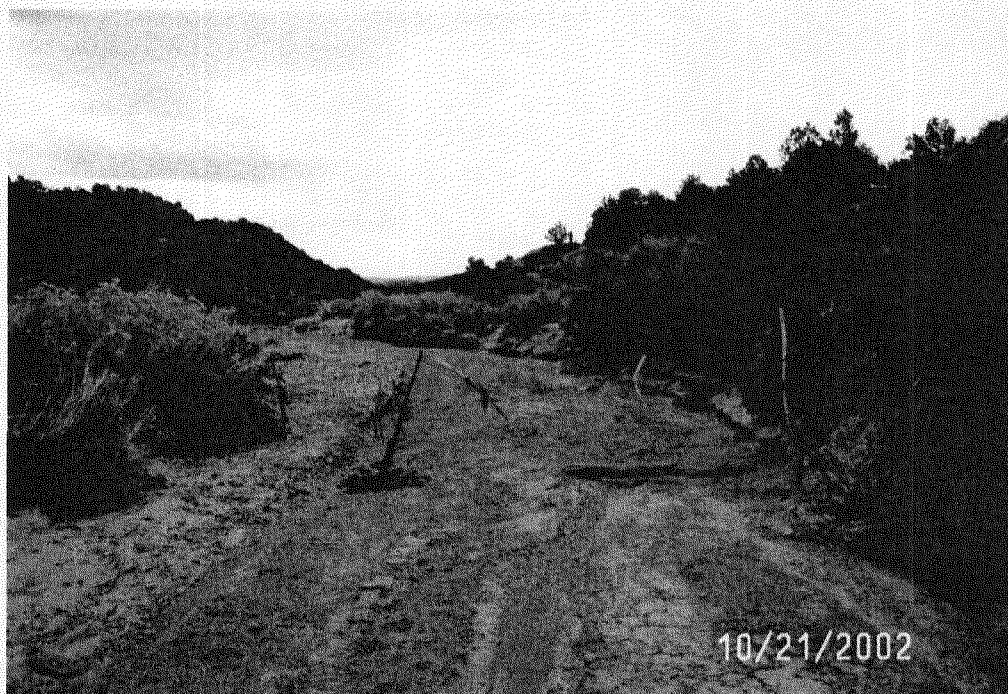
### L-19-S Little Park Wash

L-19-S is located in Little Park Wash at the permit boundary. The flow at this site is nearly the same as for L-13-S. There are no contributing sources between the two sites other than overland flow. Essentially, the data already recorded for site L-13-S is representative of the new site. Located in Alluvium adjacent to the Upper Price River Formation at an elevation of 6725 feet. Stream reach is intermittent by definition but is ephemeral acting (See Appendix 7-7 & Plate 7-4). The drainage above and below this monitoring location flows only as a result of spring run-off or storm events.

The coal seam at this location lies approximately 1400 feet below the monitoring location. Due to its location outside of the subsidence area, depth of the coal, and the tendency for the overlying formations to swell and seal, there is no potential for Lila Canyon Mine to negatively impact this monitoring location. The permittee has never observed amphibians at or near this location.

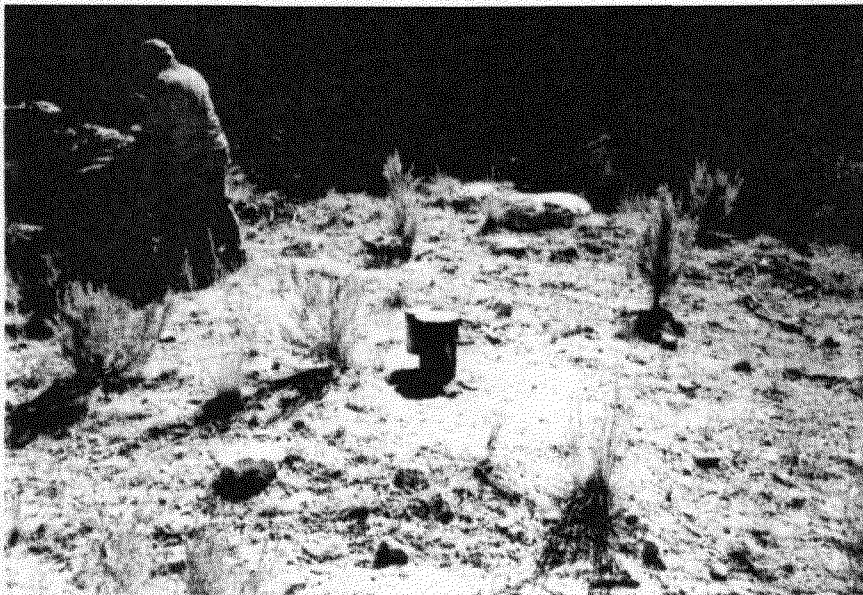
**IPA #1  
Piezometer**

**Location:** Located in an unnamed canyon that is a branch of Little Park Wash. Located in the Upper Price River Formation at an elevation of 7034 feet. See Plate 7-4 for location.

**General:** This site is used as a Piezometer measuring location only. The depth of water is measured quarterly.

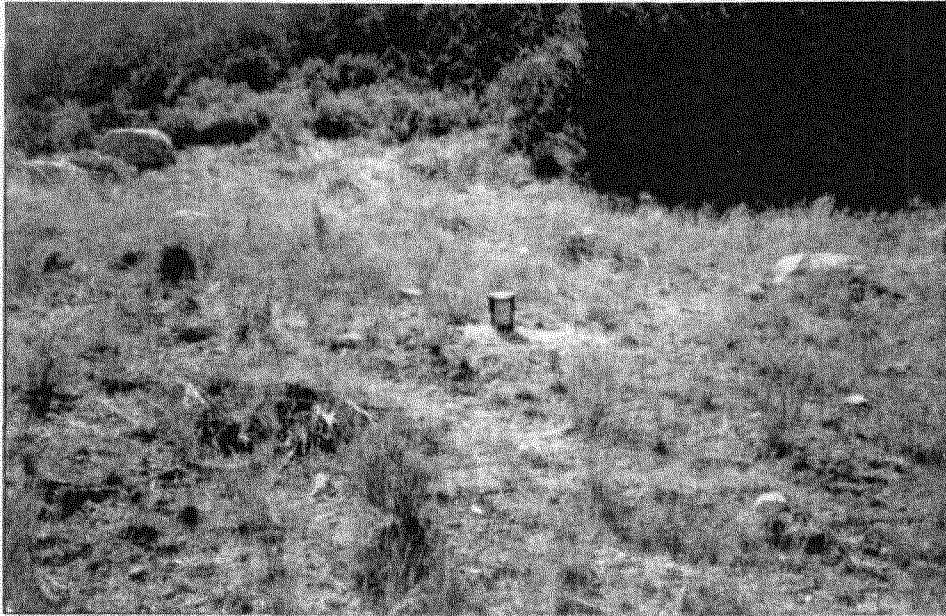
**IPA #2  
Piezometer**

**Location:** Located on the Little Park Wash road near the Little Park Wash crossing. See Plate 7-4 for location. Located in the Upper Price River Formation at an elevation of 6865 feet.

**General:** This site is used as a Piezometer measuring location only. The depth of water is measured quarterly.

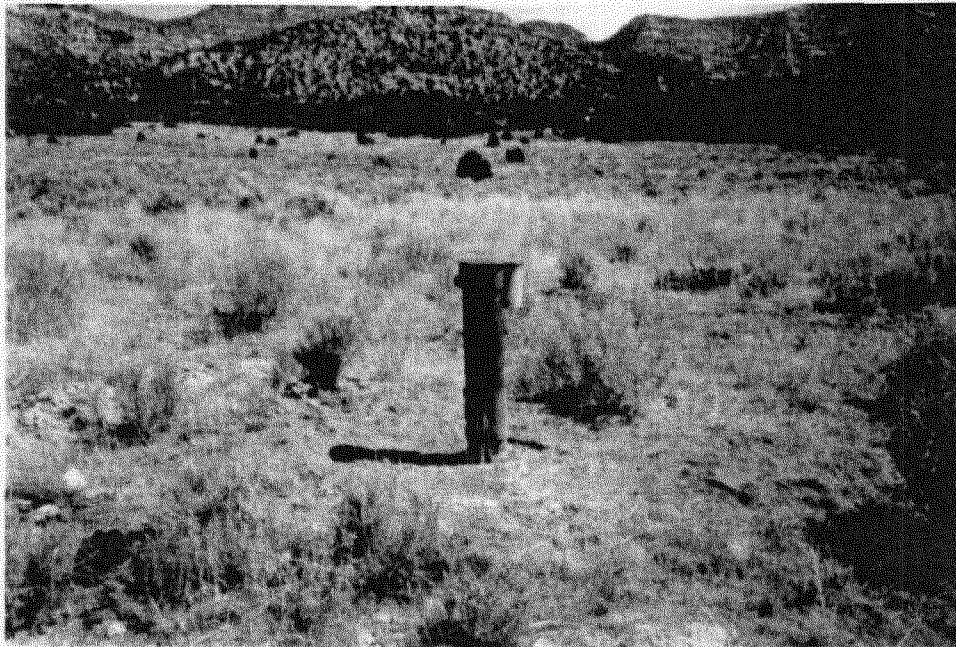
**IPA #3  
Piezometer**

**Location:** Located on the Little Park Wash road. See Plate 7-4 for location. Located in the Upper Price River Formation at an elevation of 6810 feet.

**General:** This site is used as a Piezometer measuring location only. The depth of water is measured quarterly.

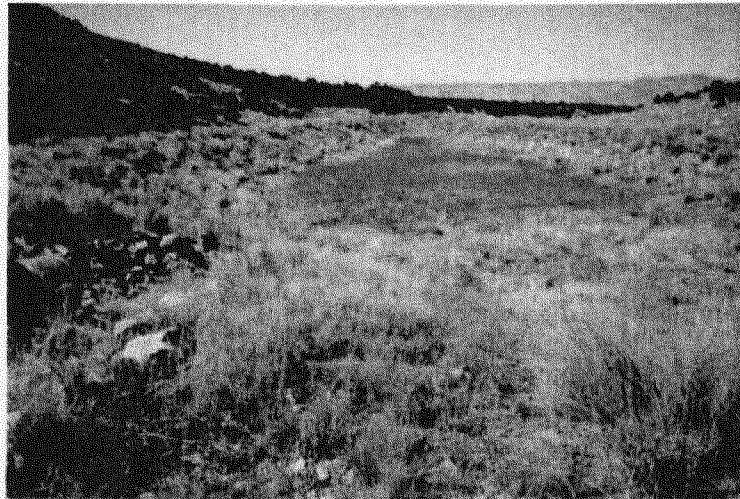
**Horse Canyon  
Sediment Pond #2  
UPDES #002A**

**Location:** Located in Horse Canyon above and to the North of the bridge on County highway 124. Located in an alluvial fan on the Mancos Shale at an elevation of 6190 feet.

**General:** This is UPDES site #002A of the Horse Canyon UPDES permit. The Sunnyside coal seam does not exist in this location. There is no potential for Lila Canyon Mine to negatively affect this monitoring site. The permittee has never observed amphibians at or near this location.

**Vegetation description:** This reseeded sediment pond is covered by a reclamation vegetation cover consistent with a sagebrush-grass habitat.

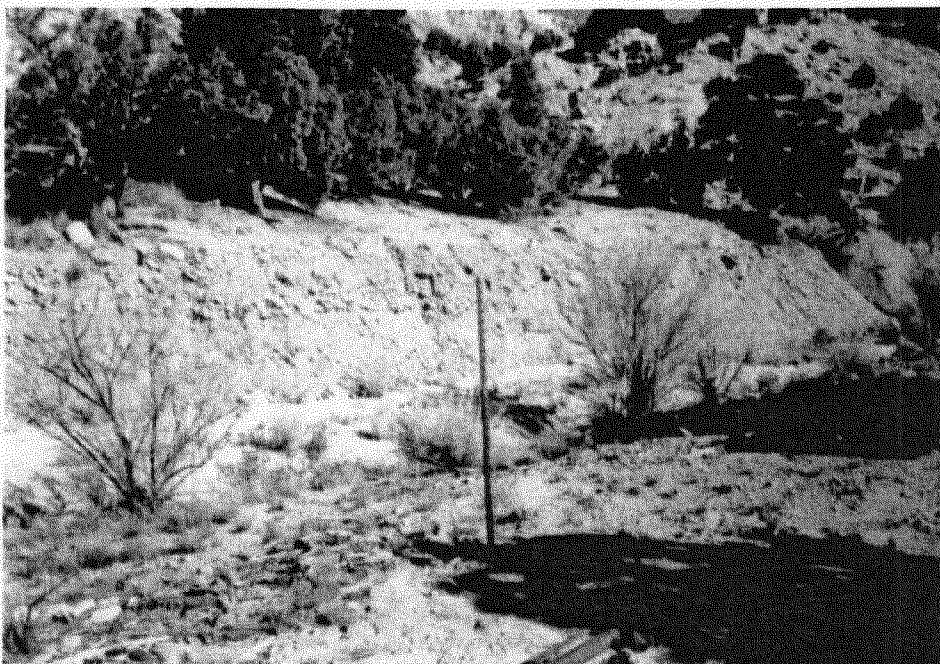
**HC-2 (B-1)**  
**Horse Canyon Below Permit Area**

- Location:** HC-2 is located in Horse Canyon Wash West and downstream of the permit area. Located in an alluvial fan on the Mancos Shale at an elevation of approximately 6100 feet. Stream reach is ephemeral by definition (See Appendix 7-7& Plate 7-4). The wash above and below flows only as a result of spring run-off or storm events.
- General:** The Sunnyside coal seam does not exist in this location. Since this site is located off the permit area and subsidence is not a possibility, there is no potential for Lila Canyon Mine to negatively affect this monitoring location. The permittee has never observed amphibians at or near this location.
- Vegetation description:** This dry channel monitoring location is surrounded by a Pinyon-Juniper overstory. Vegetation within the ephemeral acting channel is a mix of sagebrush, salt desert shrub and invasive tamarisk habitats.

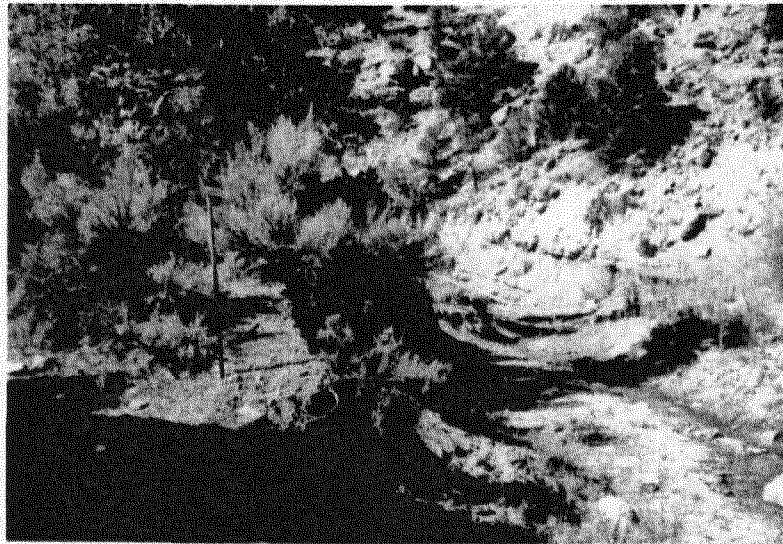
**HC-1**  
**Horse Canyon Above Permit Area**

**Location:** HC-1 is located in Horse Canyon Wash within the permit area, near the Carbon Emery county lines. Located in the Upper Price River Formation at an elevation of 6480 feet. Flow appears to be perennial due to spring inflow in the immediate area. Stream reach below this monitoring point is intermittent by definition but exhibits ephemeral flow patterns. The wash above and below flows only as a result of spring run-off or storm events.

**General:** The coal seam has been previously mined at this location. The monitoring location lies approximately 300 feet above the mined out Sunnyside coal seam. There is no potential for Lila Canyon Mine to negatively impact this monitoring location. The permittee has never observed amphibians at or near this location.

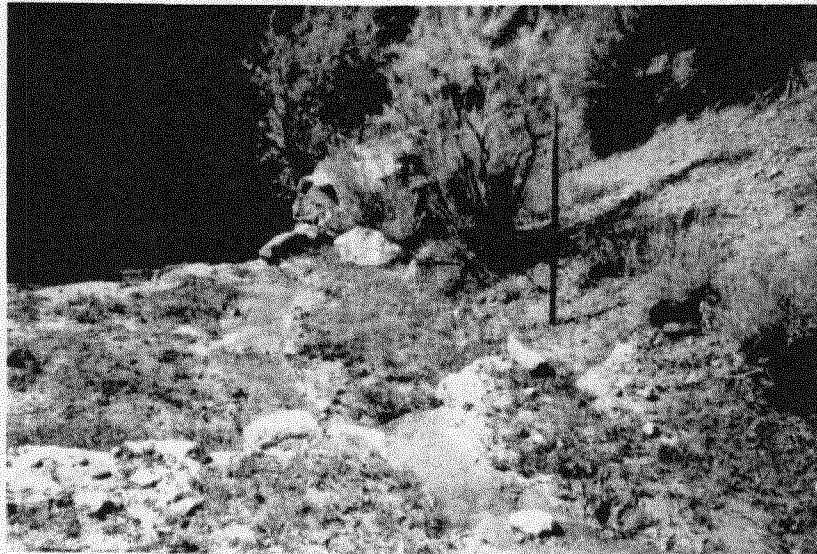
**RF-1**  
**Right Fork**

**Location:** RF-1 is located in the right fork of Horse Canyon Wash near the road forks but within the permit area. Located in the Upper Price River Formation at an elevation of 6480 feet. Flow appears to be perennial due to Redden Spring inflow. Flow continues for approximately 300 feet below the monitoring location where the stream reach becomes ephemeral. The wash 700 feet below flows only as a result of spring run-off or storm events.

**General:** The coal seam has been previously mined at this location. The monitoring location lies approximately 300 feet above the mined out Sunnyside coal seam. There is no potential for Lila Canyon Mine to negatively impact this monitoring location. The permittee has never observed amphibians at or near this location.

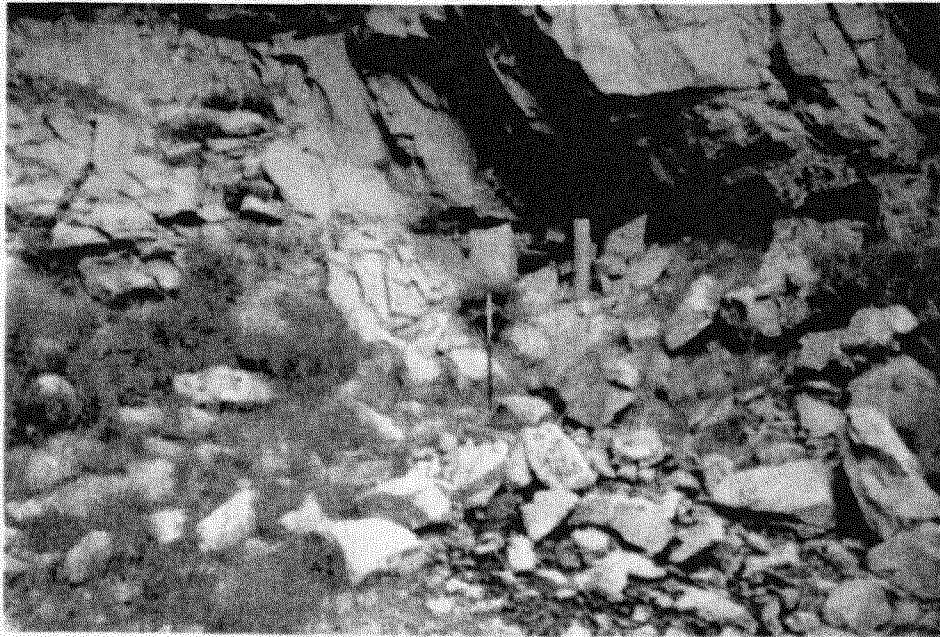
**RS-2**  
**Redden Spring**

**Location:** Redden Spring is located in the right fork of Horse Canyon Wash near the road forks but within the permit area. Located at the base of the Flagstaff/North Horn Formation at an elevation of 6592 feet. The wash above flows only as a result of spring run-off or storm events.

**General:** The coal seam has been previously mined at this location. The monitoring location lies approximately 800 feet above the mined out Sunnyside coal seam. There is no potential for Lila Canyon Mine to negatively impact this monitoring location. The permittee has never observed amphibians at or near this location.
